# Analysis of the Kláštorské lúky wetland

**Dept. of Land and Water Resources Management  
Slovak University of Technology  
in Bratislava**

- within the framework of the GEF project „Conservation, Restoration and Wise Use of Rich Fens in the Slovak Republic“
- DAPHNE - Institute of Applied Ecology
- Analysis of hydrological regime of wetlands
- To identify reasons of wetlands degradation:
  - Changes in hydrological regime
  - Human activities (drainage systems)
  - **Changes in management of wetlands**
- Proposal of measures to improve hydrological regime

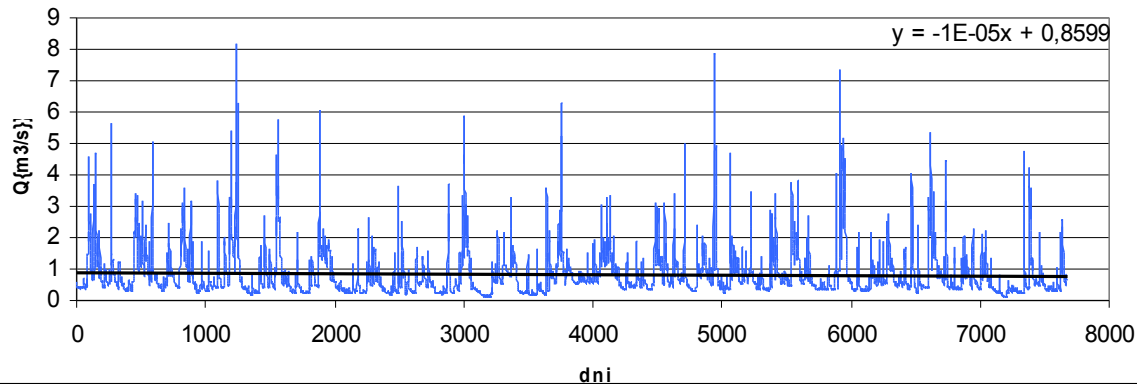
Kláštor p.Znievom - Vrica (1.1.1984 - 31.12.2004)

# Kláštor pod Znievom – Vrica- discharges

- **Problems – no gauged data**
- **Short time series**
- **Kláštôr pod Znievom - Vríca**
  - trend of mean daily discharges is slightly decreasing for the whole period of observation
  - decrease in mean daily discharges is little higher in the last period of 2000-2004 (mean daily discharge = 0,732 m<sup>3</sup>/s, max. daily discharge = 0,783 m<sup>3</sup>/s), in 1984-2004 mean daily discharge = 0,808 m<sup>3</sup>/s, max. daily discharge = 0,819 m<sup>3</sup>/s)
- **Slovany – Vríca**
  - trend of mean daily discharges is slightly decreasing
- **Time series of discharges in both stations were homogenous**

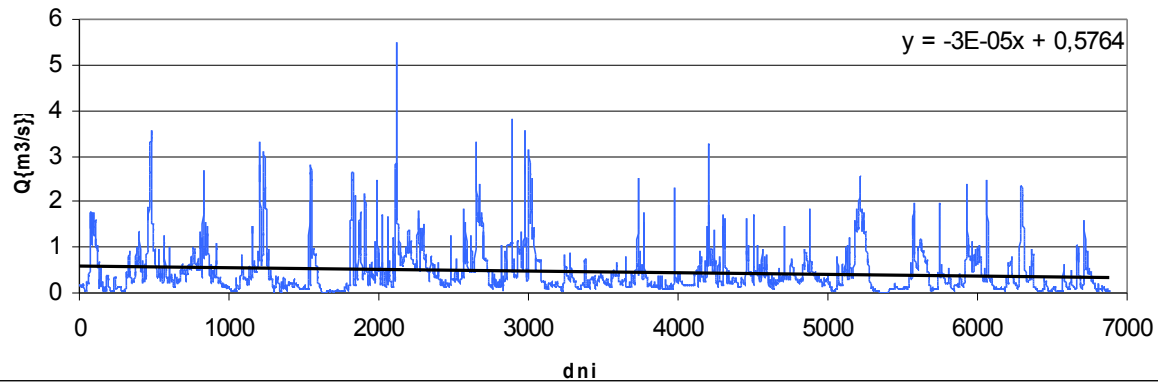
**Slovany - Vrica (1.1.1969 - 31.12.1987)**

# Slovany - Vrica discharges

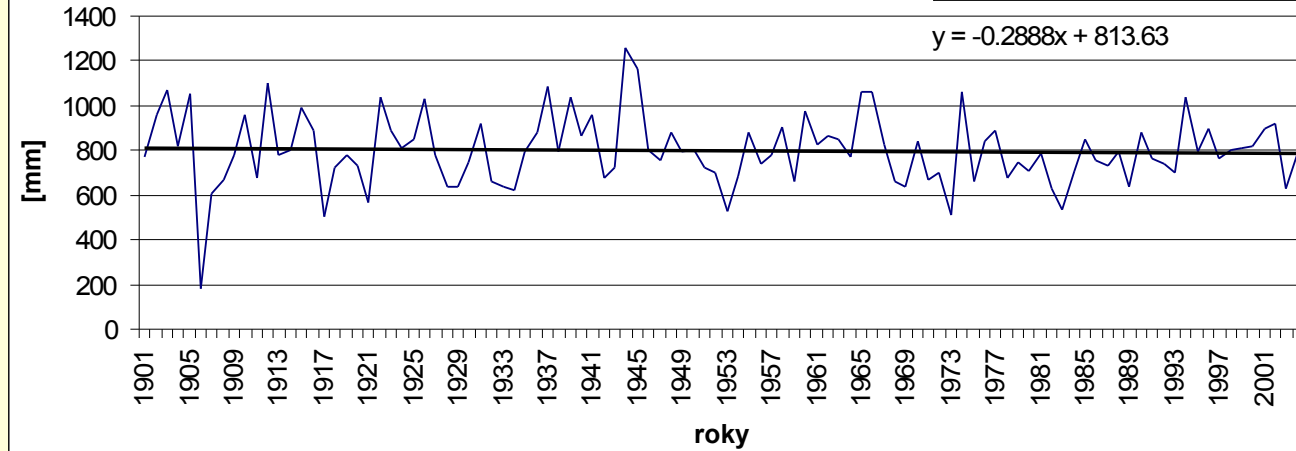
Kláštor pod Znievom - ročné úhrny zrážok [mm]

# Kláštor pod Znievom - precipitation

$$y = -0.2888x + 813.63$$

- Slight decrease in annual precipitation totals in all stations
- about 30 mm/year within 100 years period of observation
- From 30 years period the most dry period was in 1961-1990

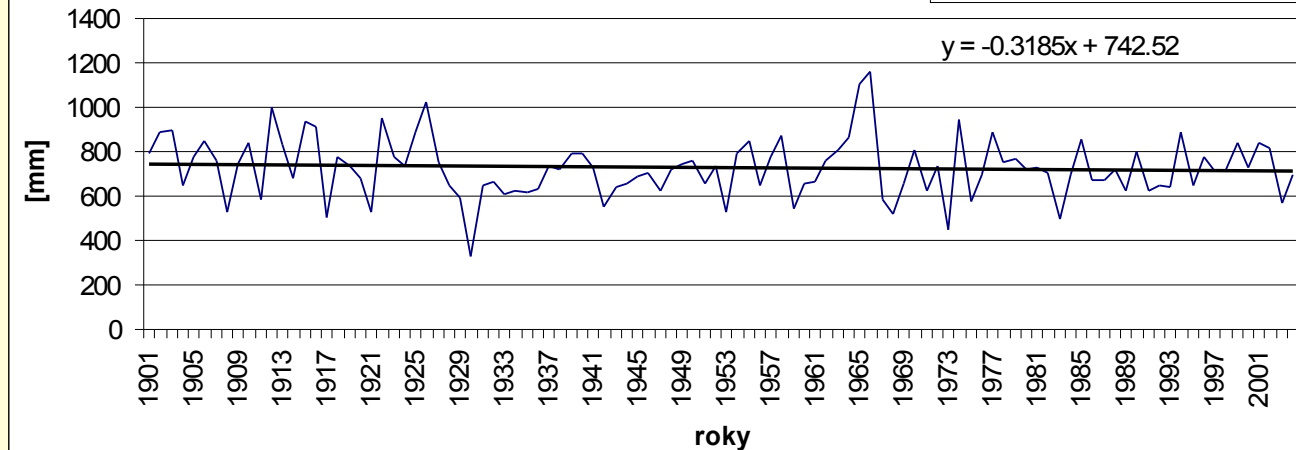
Príbovce - ročné úhrny zrážok[mm]

$$y = -0.3185x + 742.52$$

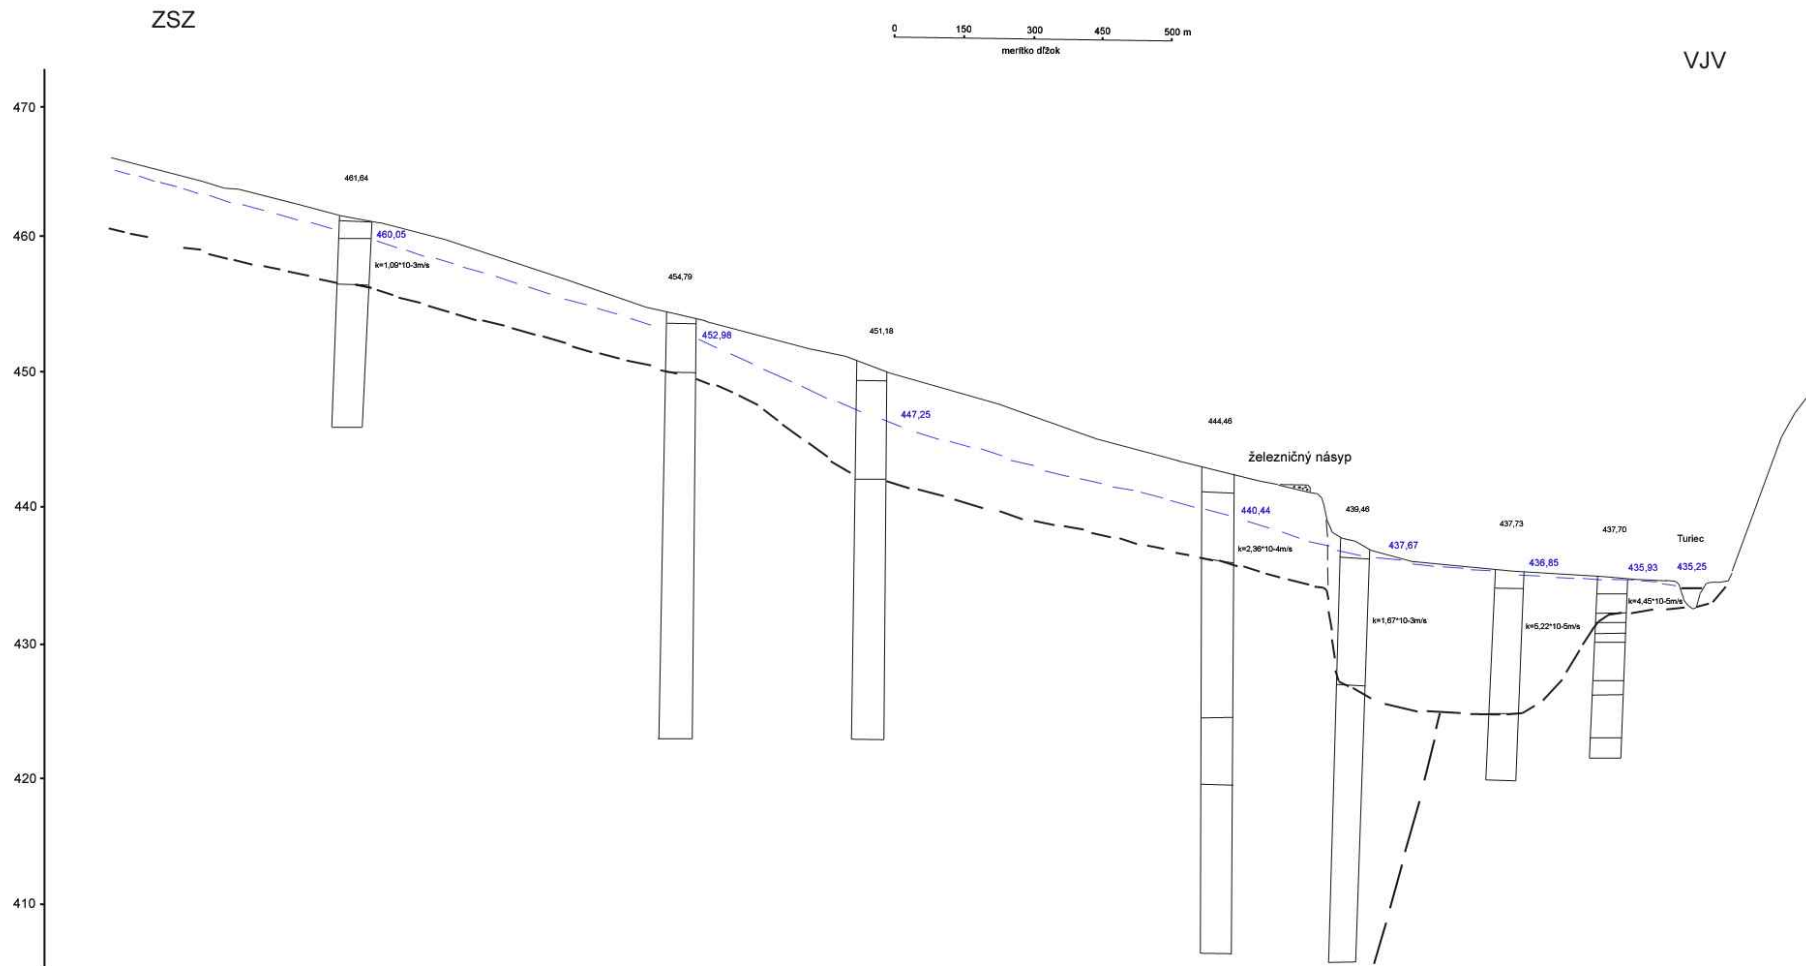
# Hydrogeological profile of sediments of the Suchá Vřica river

- **Gravel-sandy fluvial sediments of the Suchá Vřica river**
- **Lower layer consists of clays**

Schematický hydrogeologický rez pozdĺž náplavového kužeľa Suchej Vřice a naprieč poriečnou  
nívou Turca v priestore Kláštor p/ Znievom - Socovce

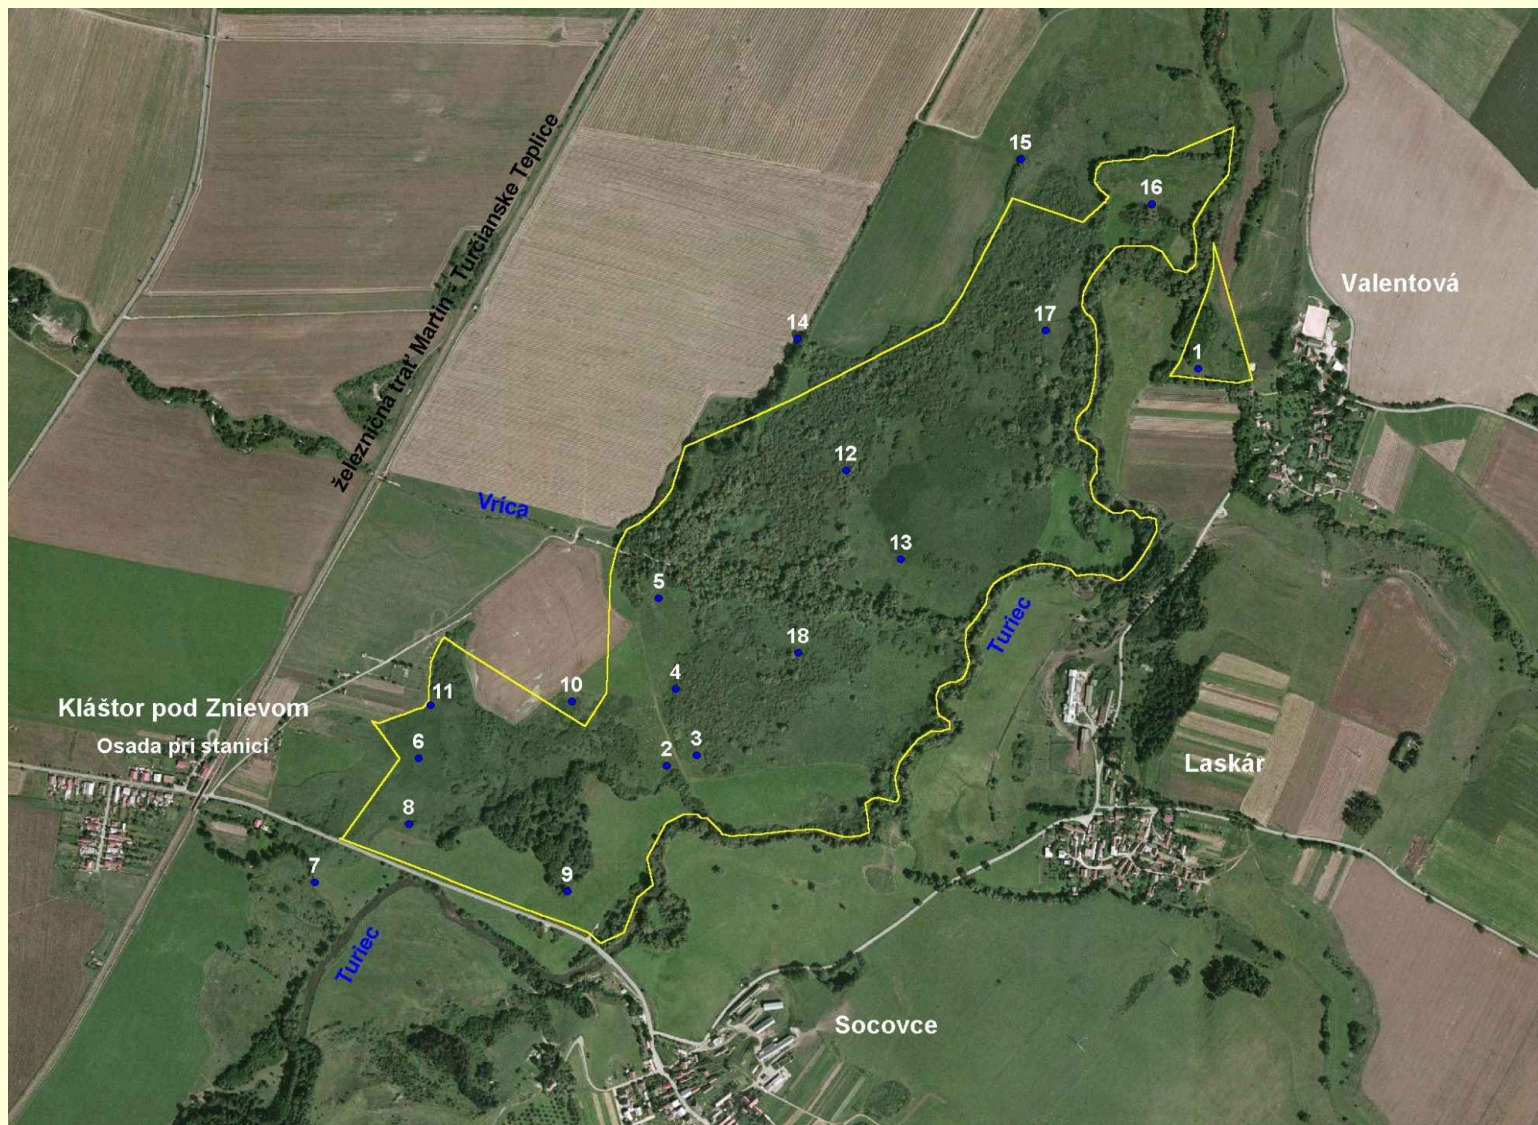
## New network of ground-water observation (1-18) from 2005

- **1 observation object provided by SHMI (Klášt'or pod Znievom č. 463, observation from 1958)**
- **1996 – 2004 – 6 observation objects in the wetland region (some of them were stolen, observation finished)**
- **From 2005 – observation in 18 objects, new location was proposed**

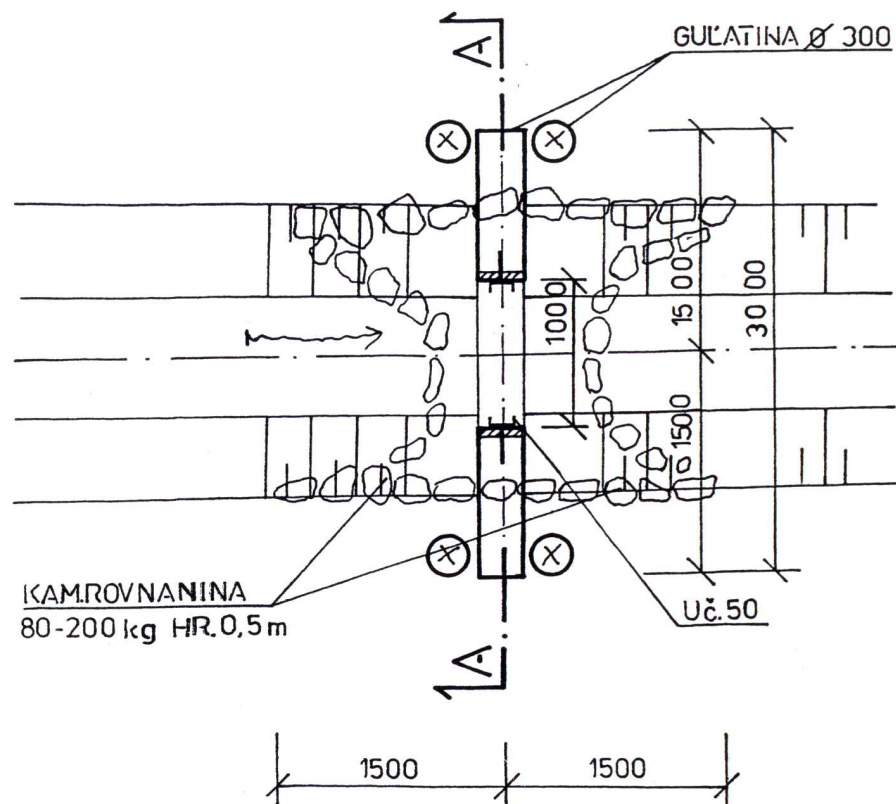
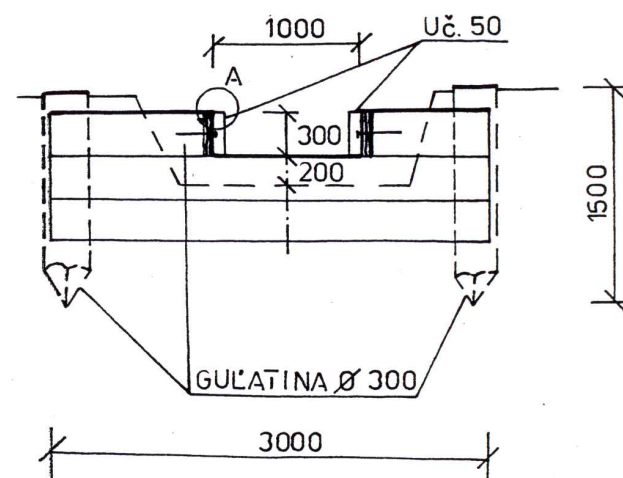
# Návrh prehrádzky na odvodňovacom jarku (EKOSPOL) - pôdorys a rez A - A'

PÔDORYS M=1:50

REZ A-A'

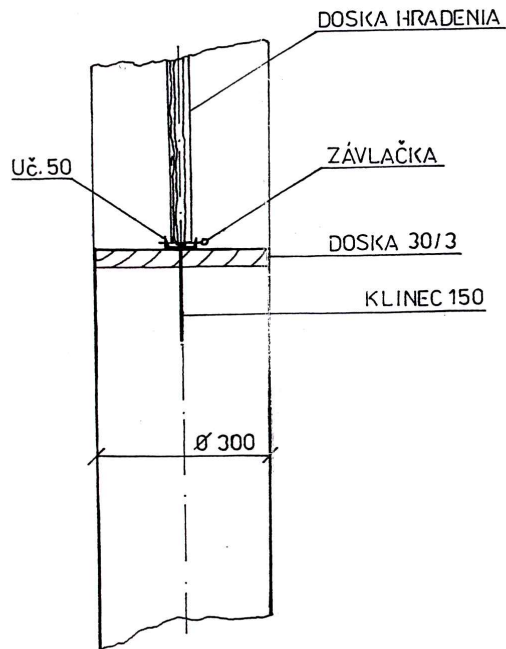
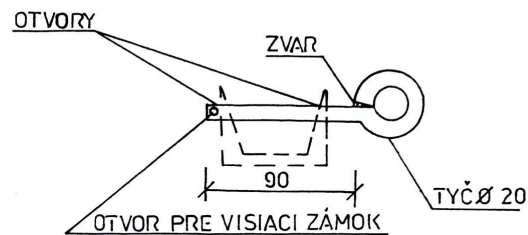
## Návrh prehrádzky na odvodňovacom jarku (EKOSPOL) - detail A a závlačka

DETAIL A  
M=1:10

ZÁVLAČKA

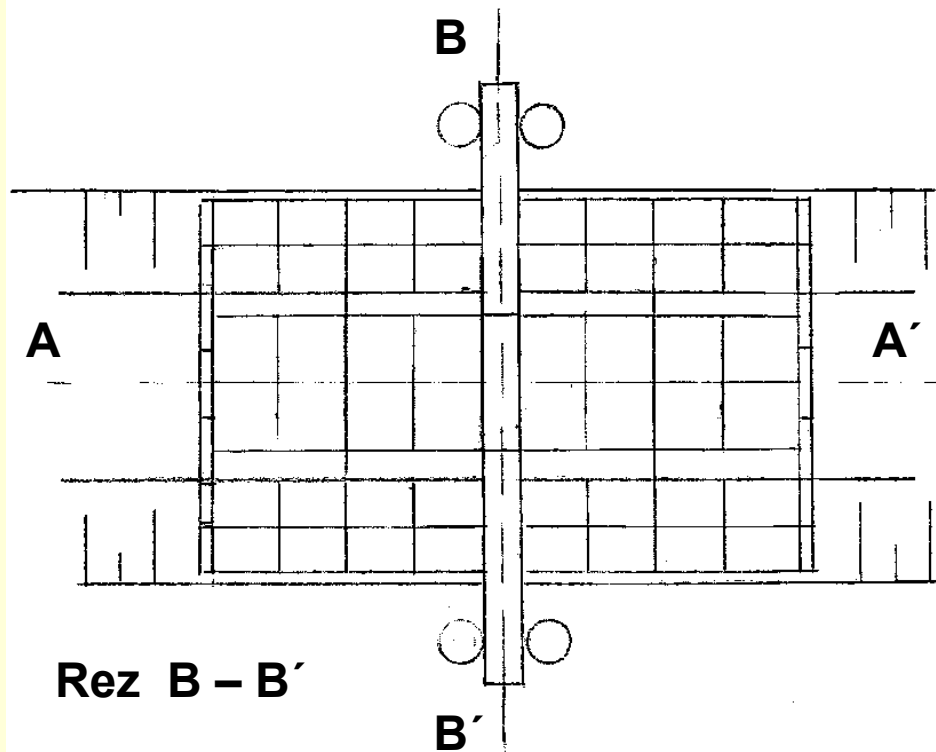
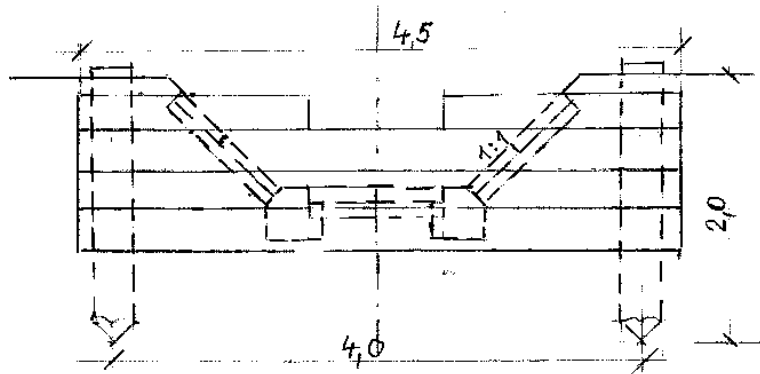
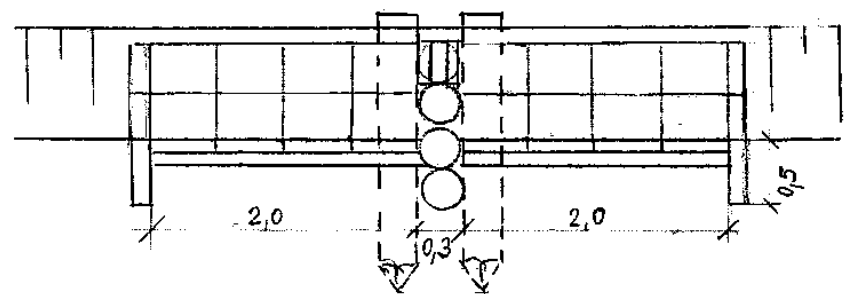
# Návrh prehrádzky na odvodňovacom jarku (KVHK)

Rez B – B'

Rez A – A'

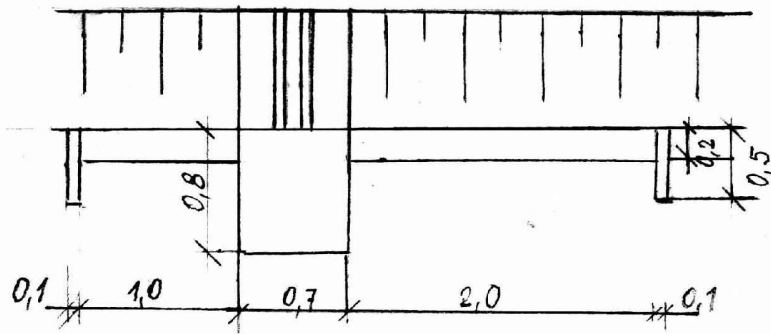
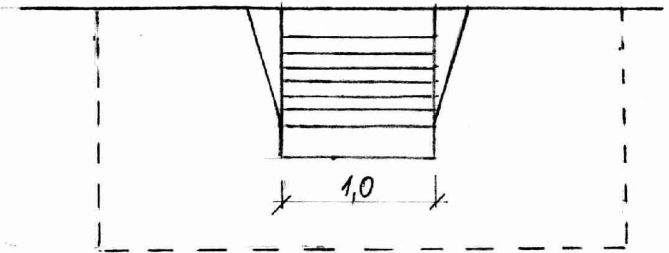
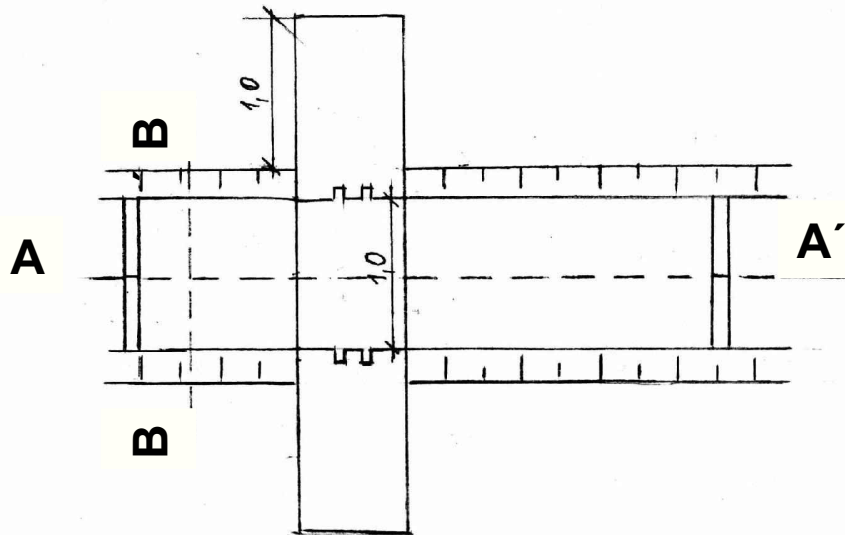
# Návrh prehrádzky na odvodňovacom jarku (KVHK) - pôdorys a rez A - A'

Rez A - A'

Rez B - B'
