## ***„ Experience of mire restoration in the Šumava National Park***

*Ivana Bufková  
and all sumava LIFE people*

# Šumava National Park – important wetland area

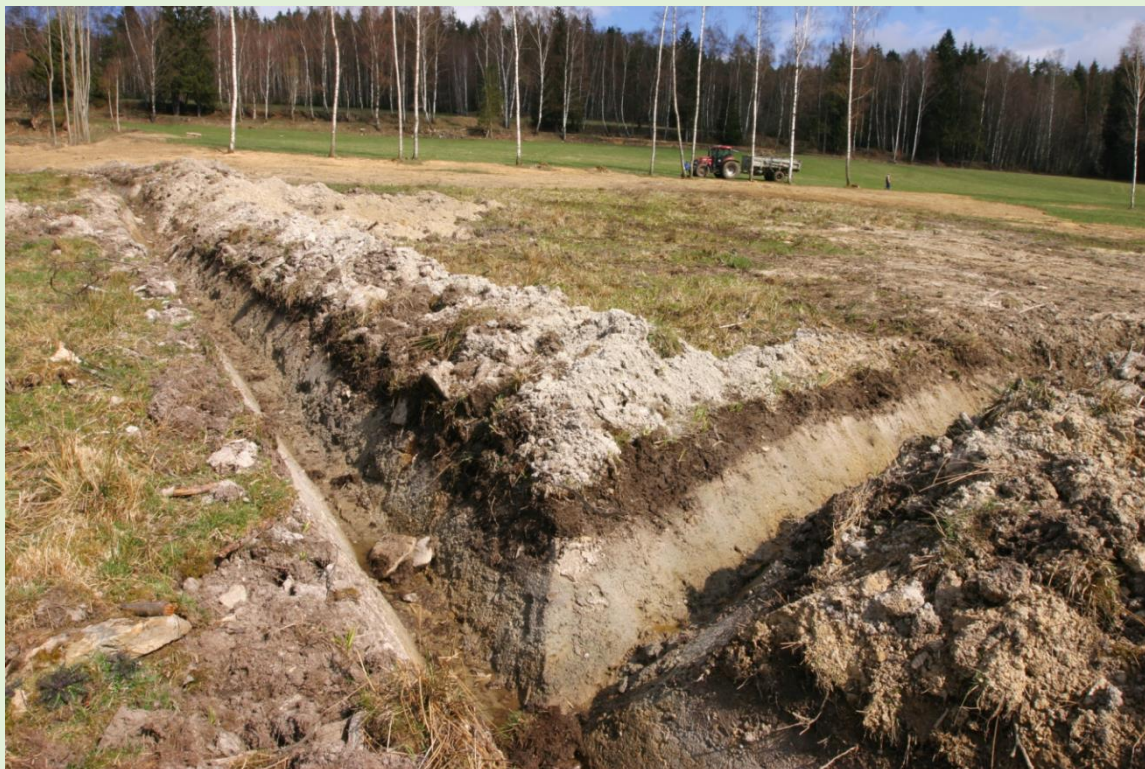
*Drained meadow spring for agriculture*

*Drained bog forest for forestry*

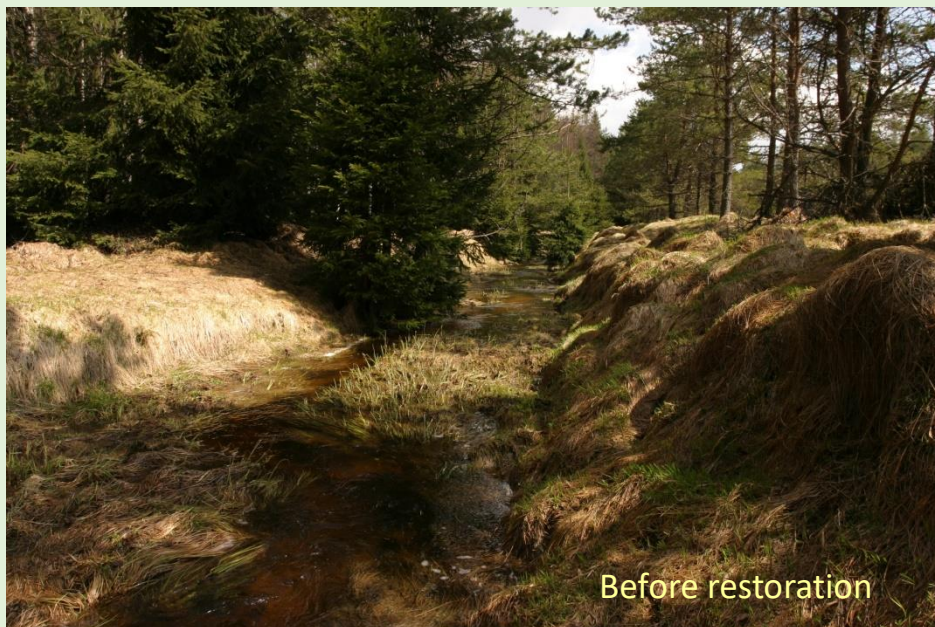
Before restoration

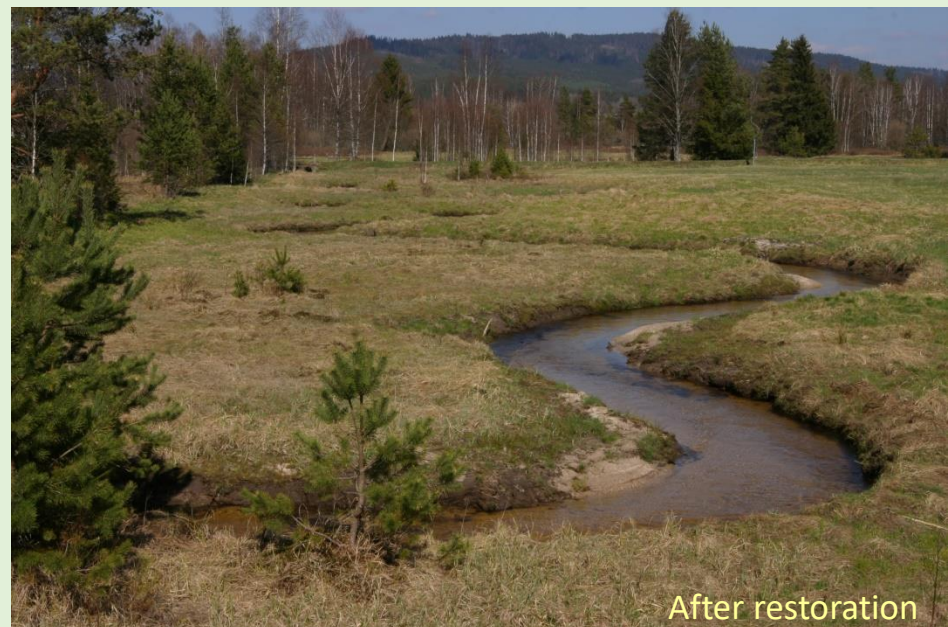
After restoration

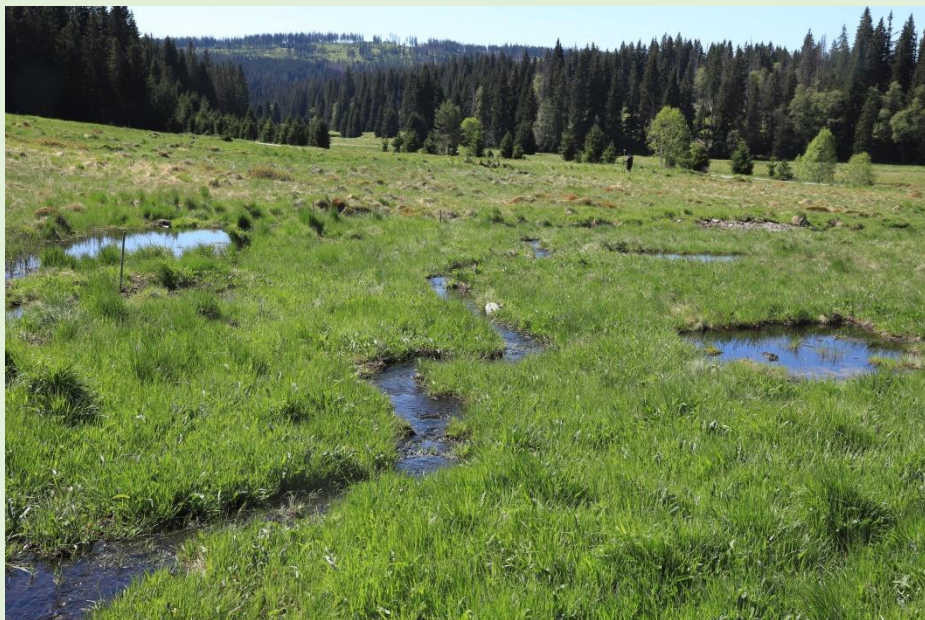
Restored natural stream, blocked ditches and created small pools in the site Rybarný I

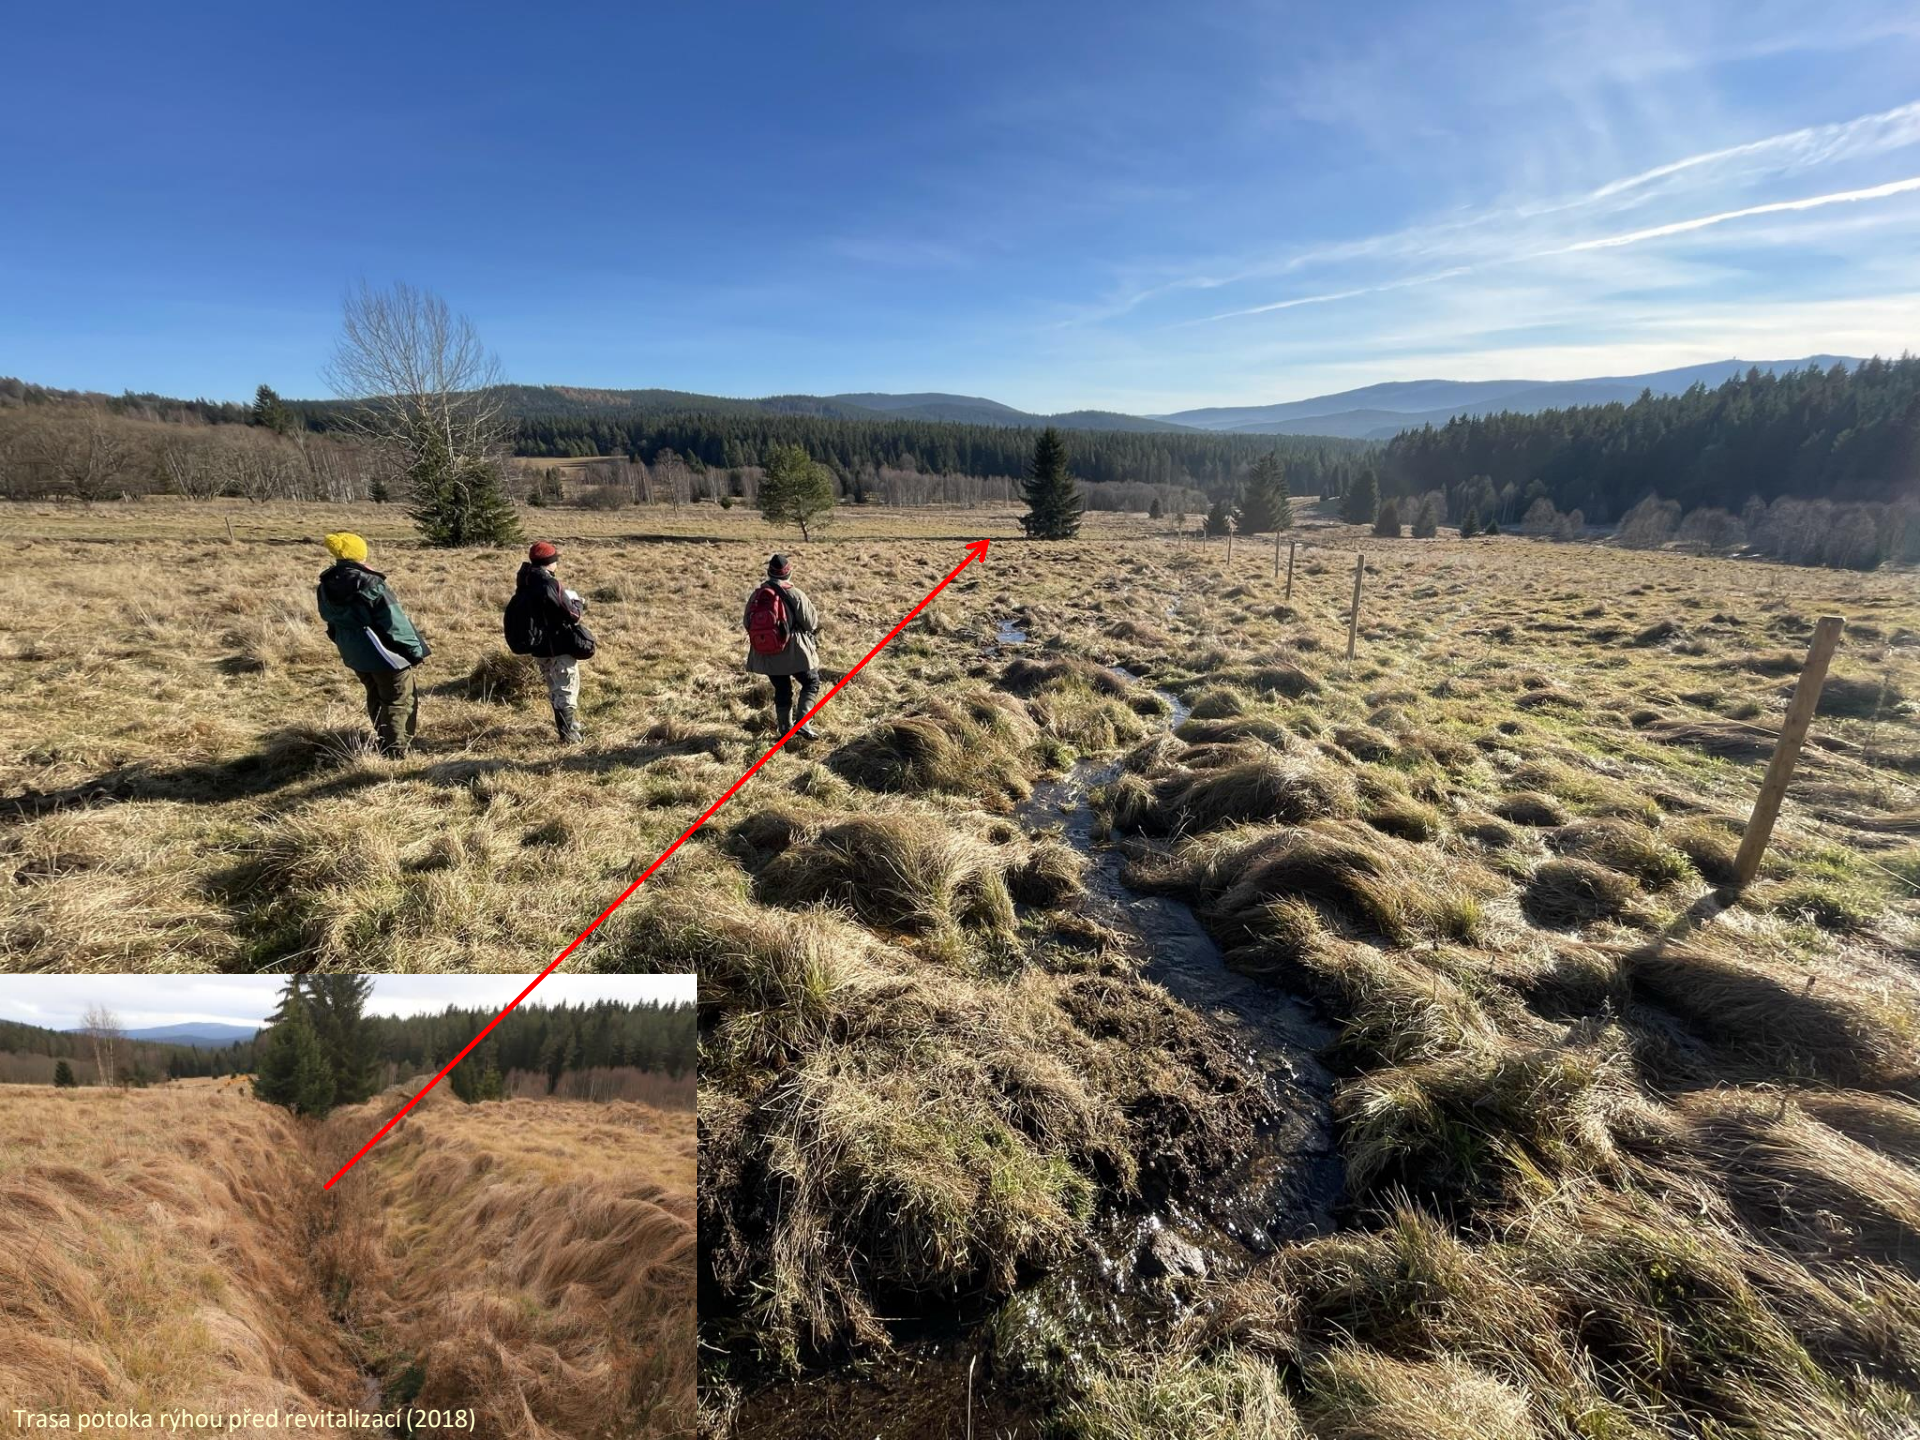
Odvodněné prameniště před revitalizací (2019)

Trasa potoka rýhou před revitalizací (2018)

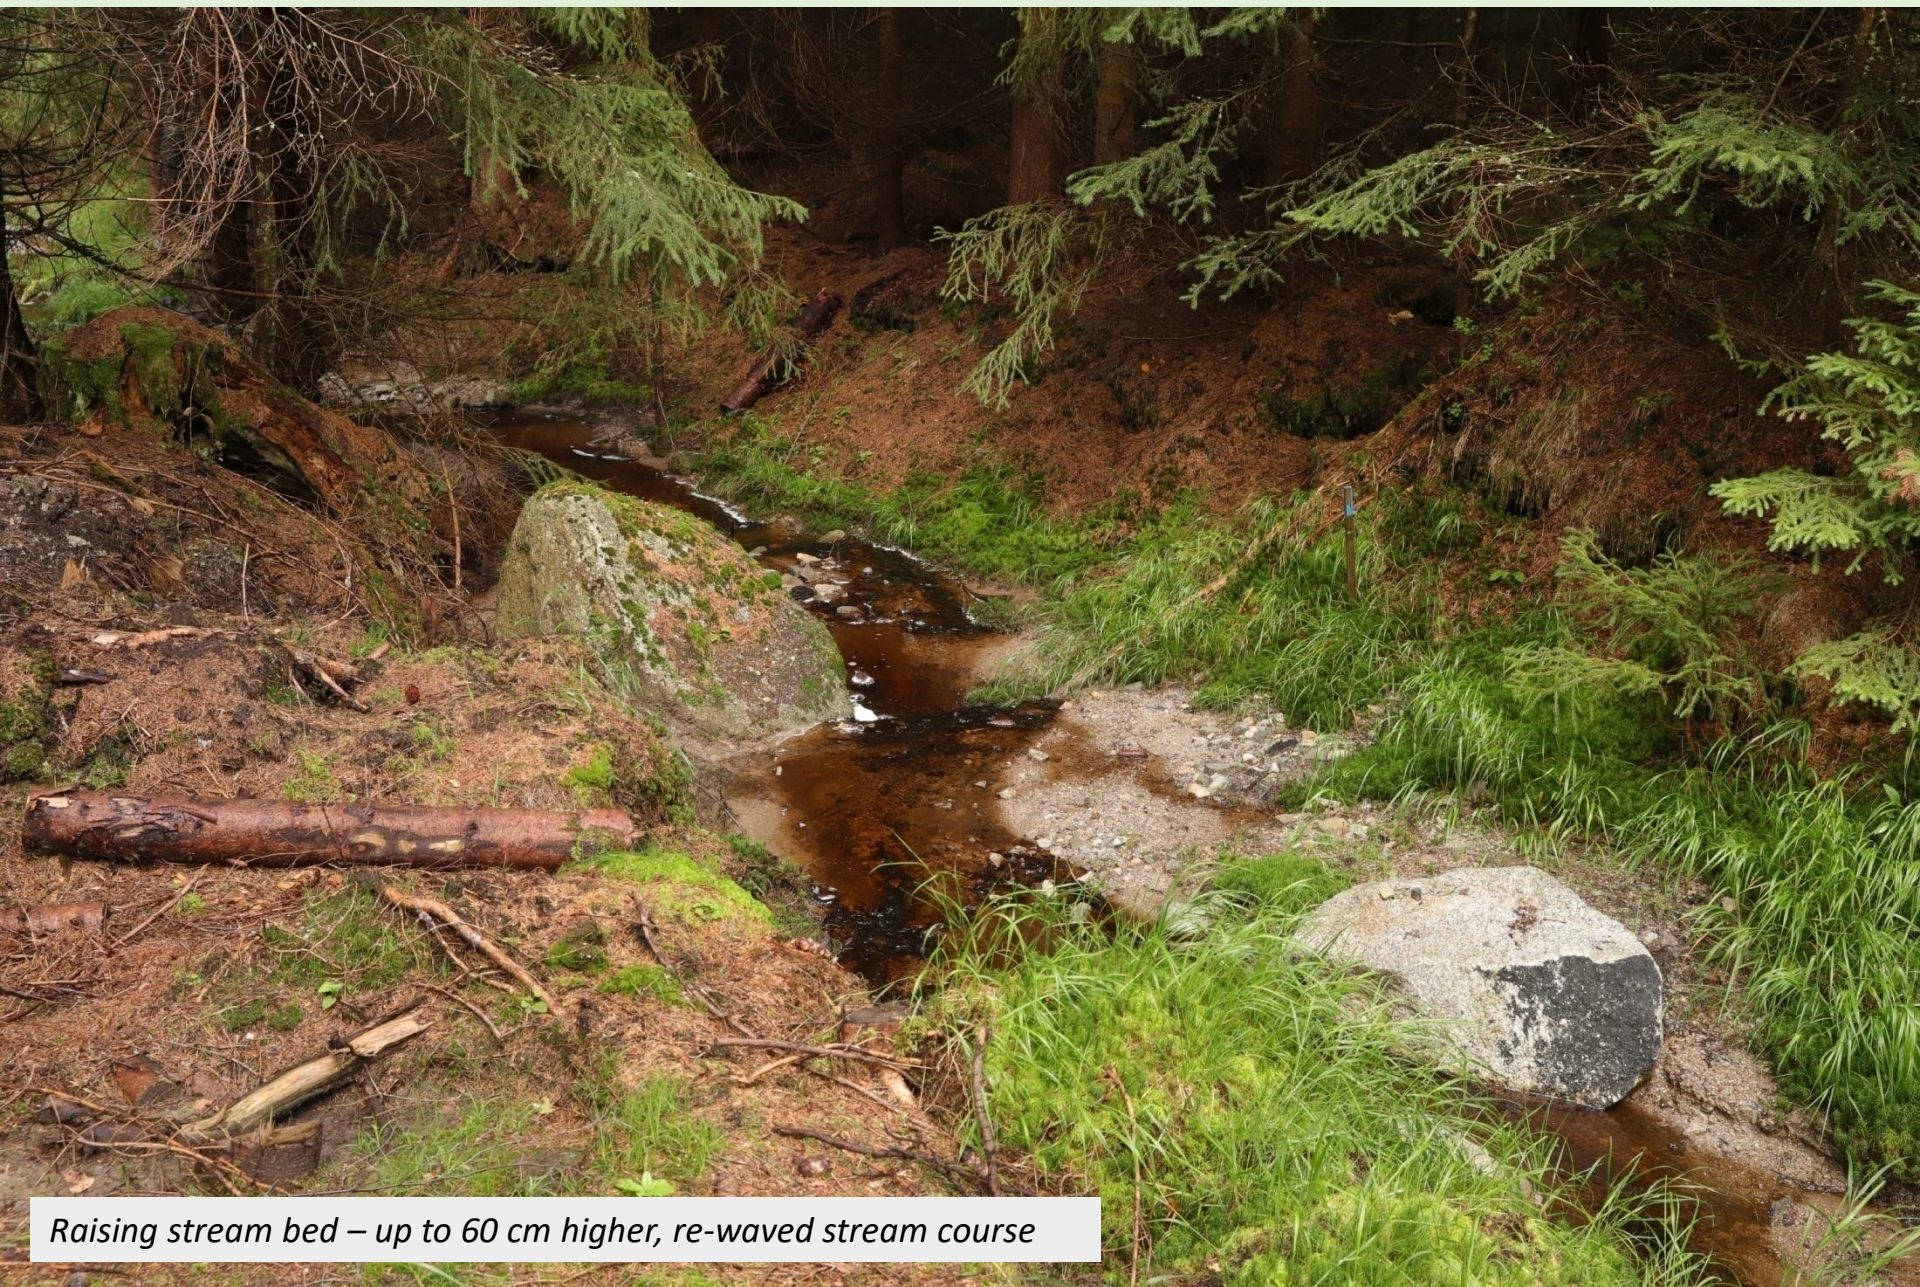
*Raising stream bed – up to 60 cm higher, re-waved stream course*

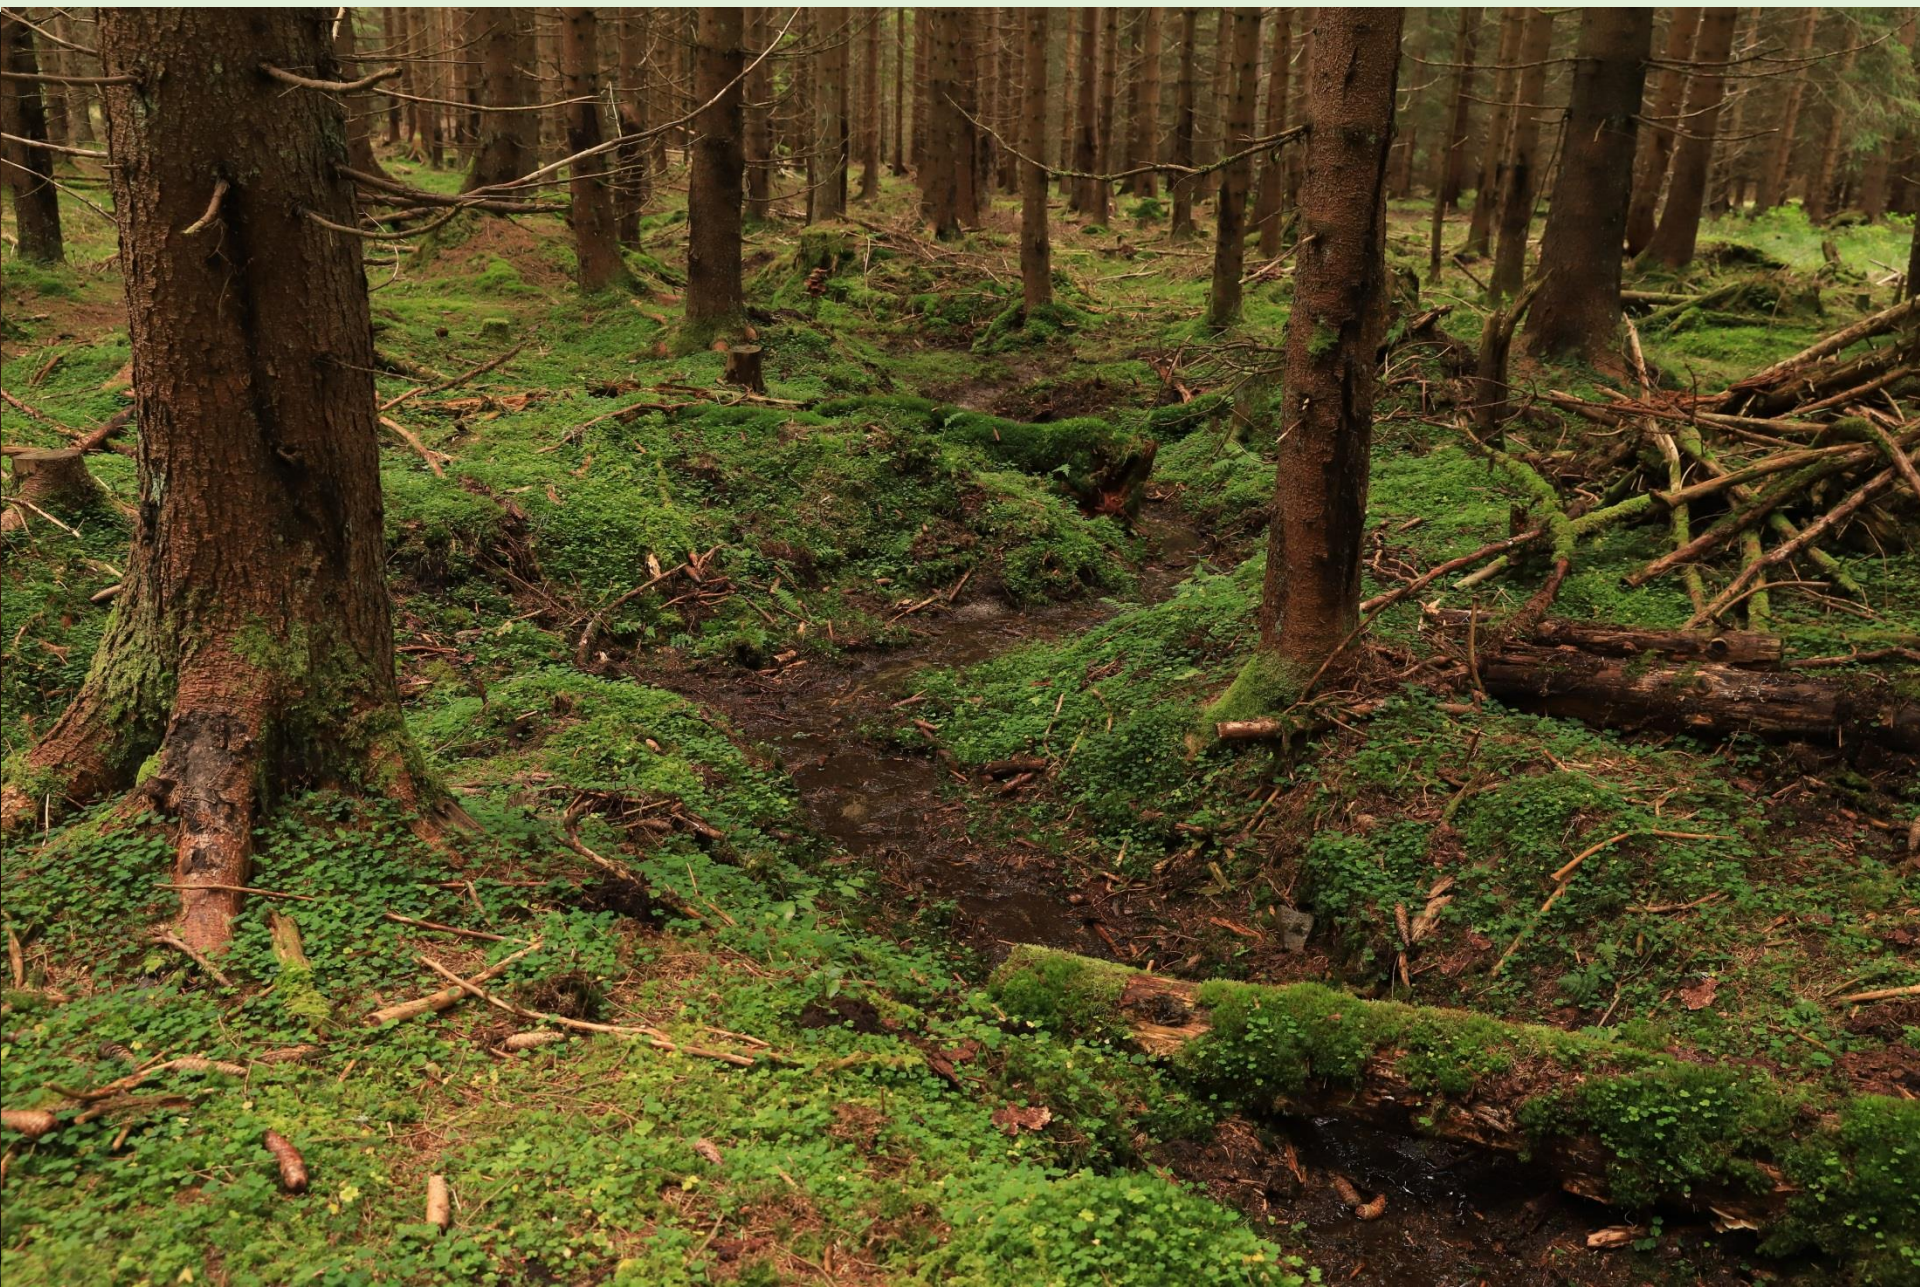
Nové Údolí – obnova lesního potoka, převedení do zachovalého původního koryta

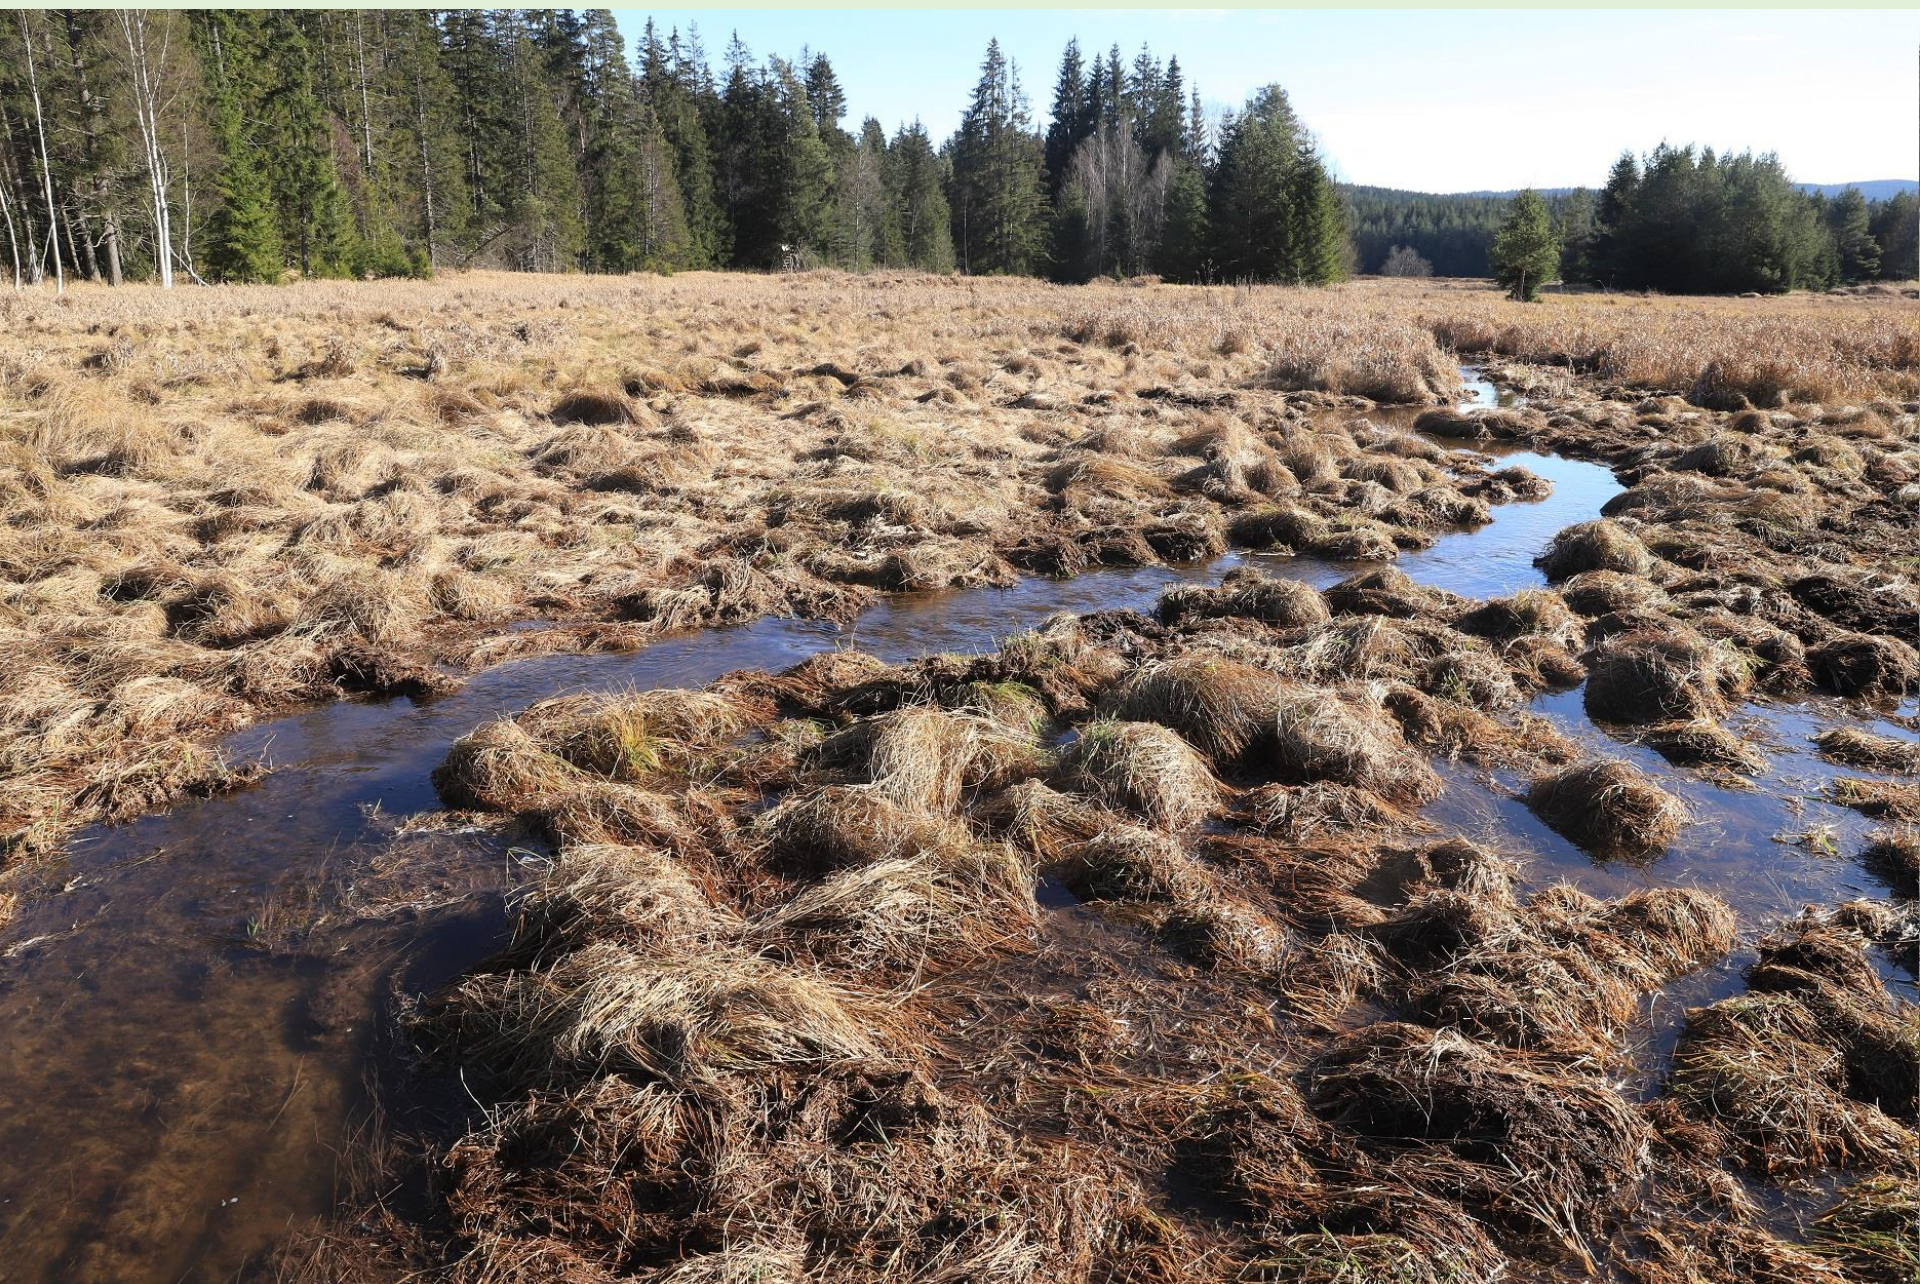
Nové Údolí – obnova lučního potoka, převedení do původního koryta

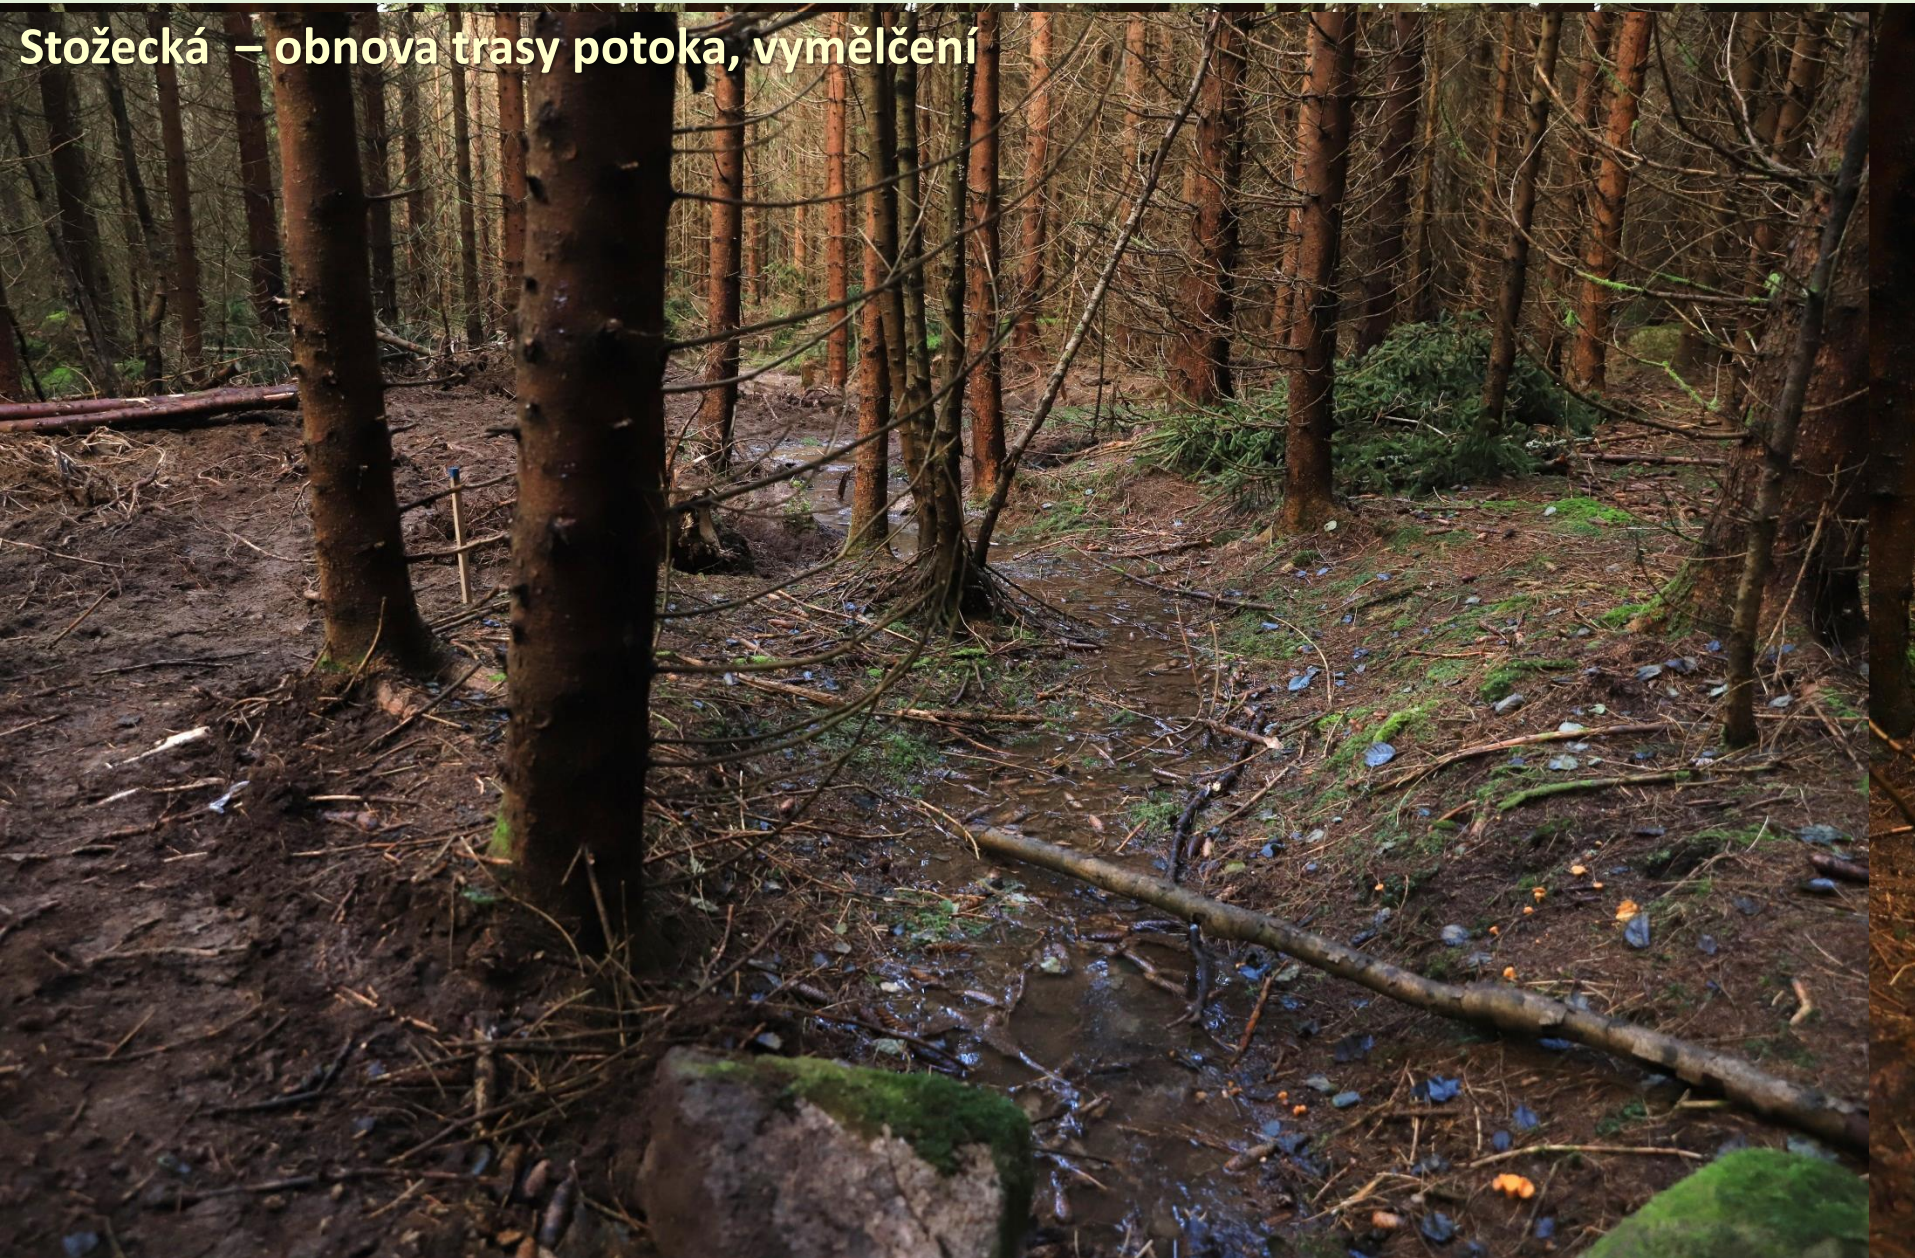
## Stožecká – obnova trasy potoka, vyměščení

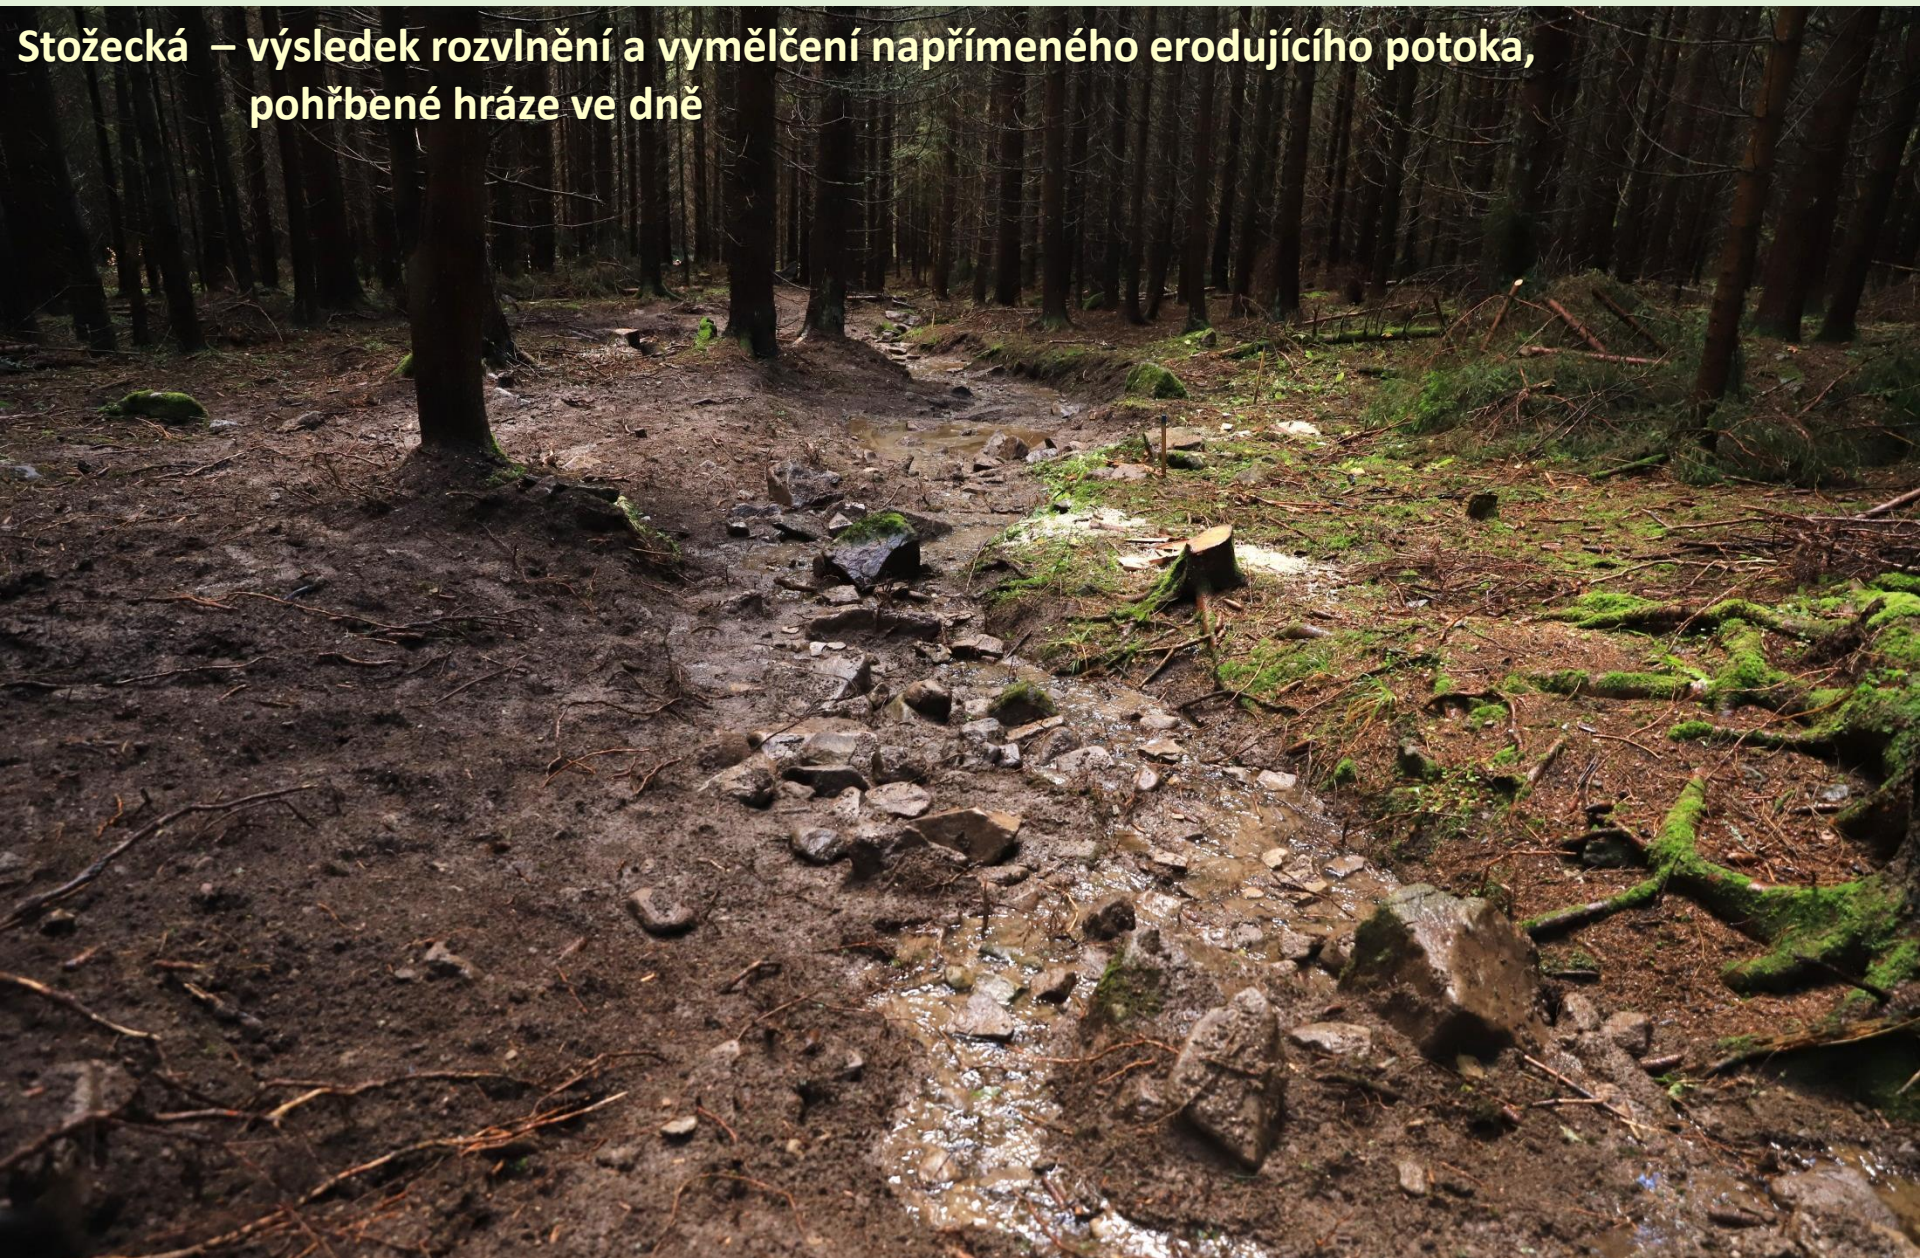
**Stožecká – výsledek rozvlnění a vymělčení napřímeného erodujícího potoka,  
pohřbené hráze ve dně**

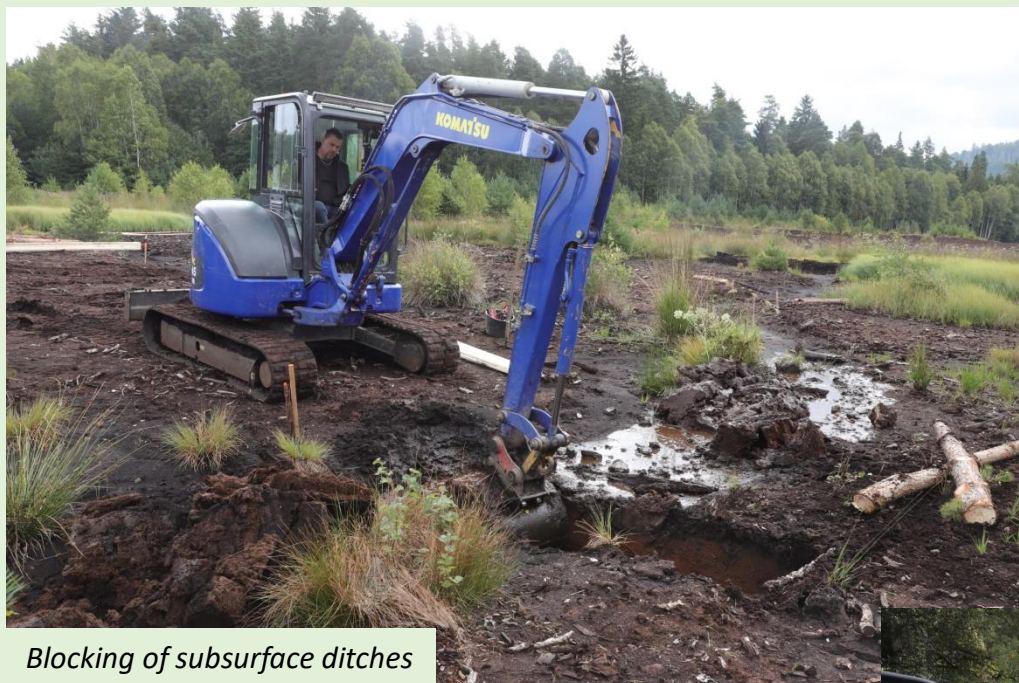
*Blocking of subsurface ditches*

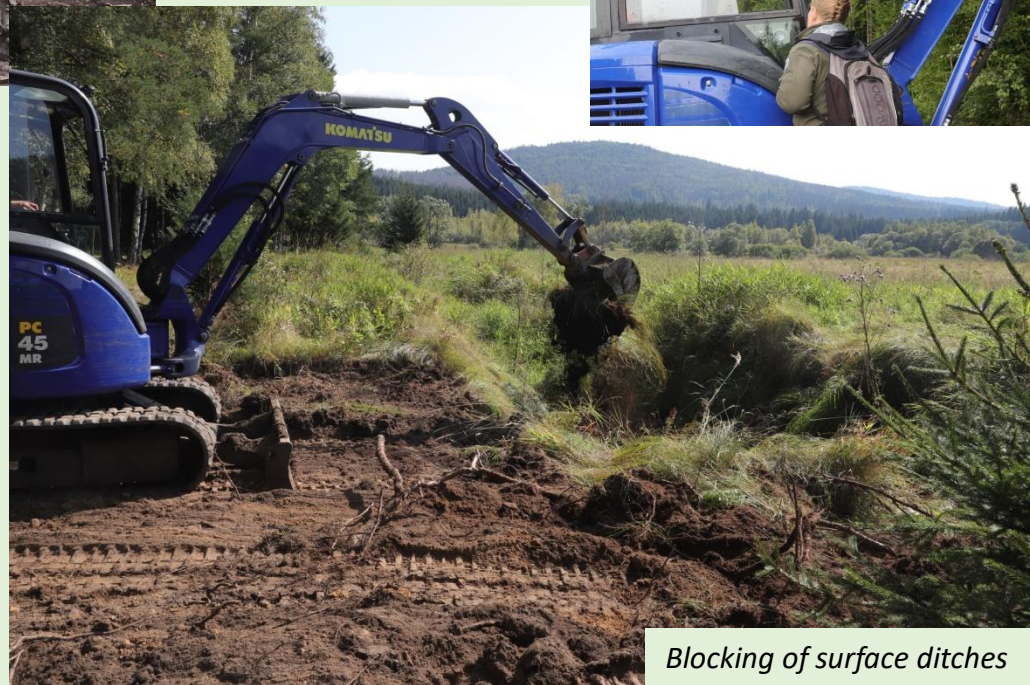
*Blocking of surface ditches*
